LOWER BLUE CREEK RECONNAISSANCE OF STORED SEDIMENT TECHNICAL MEMORANDUM

Midnite Mine Superfund Site – Spokane Indian Reservation, WA

Revision 2

September 2015

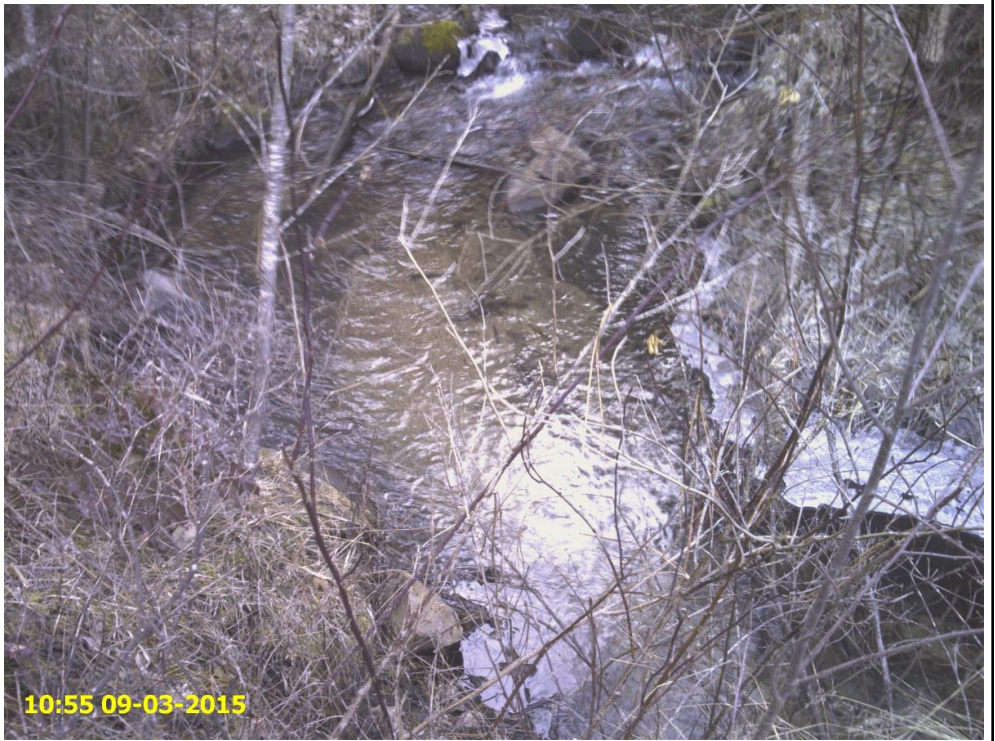
Photo Location: Lower Reach, Station L-I			
Direction:			
Survey Date: 3/9/2015			
Comments: Photo shows a typical mid-stream sand-sized particle sediment deposit, approximately 1 cubic foot volume.

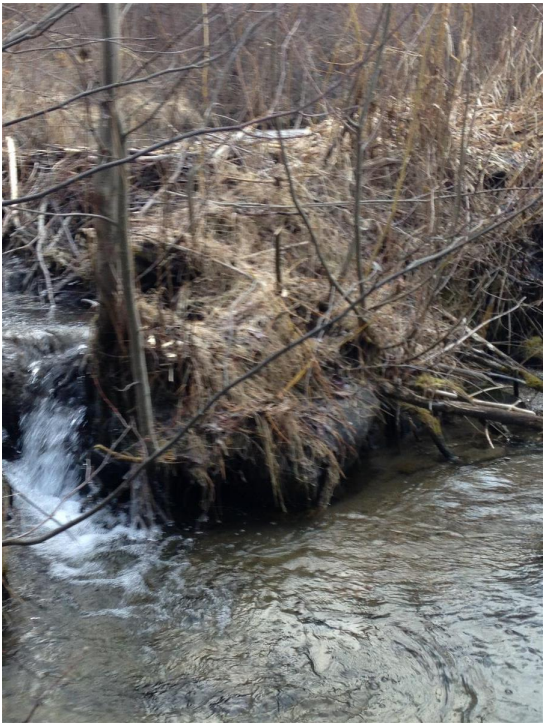
Client:	Newmont	Project:	Lower Blue Creek Reconnaissance
Site Name:	Midnite Mine	Site Location:	Lower Blue Creek
Photograph ID: 37

Photo Location: Lower Reach, Station L-I			
Direction:			
Survey Date: 3/9/2015			
Comments: Pool stream type. Stream bottom composition of gravel with sand-sized sediment.			
Photograph ID: 38

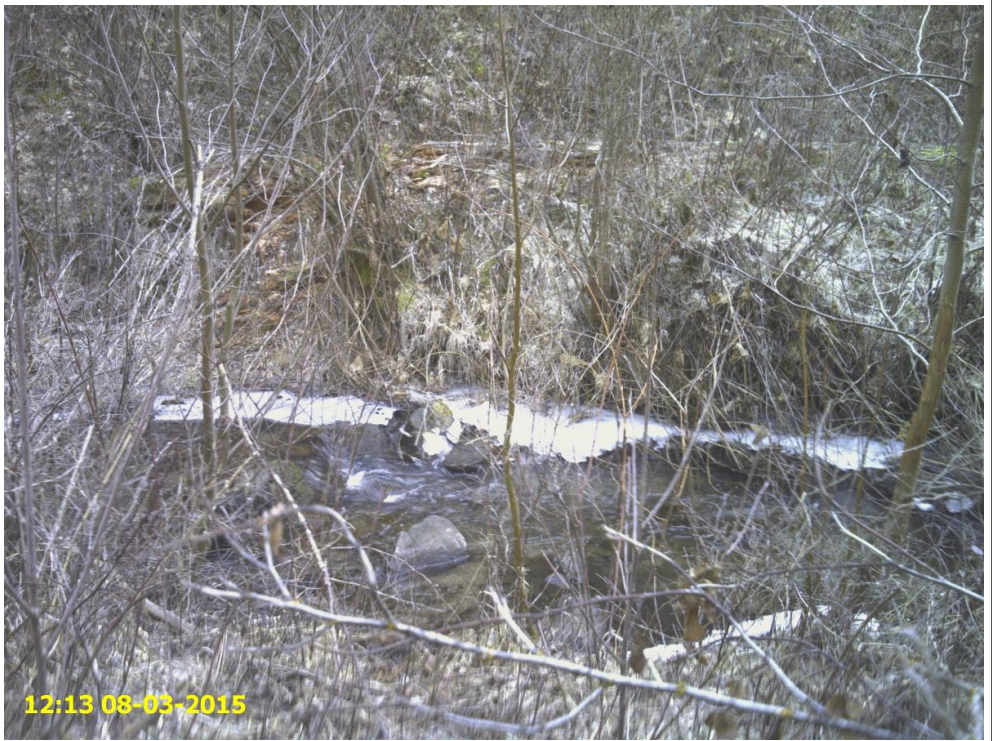
Photo Location: Lower Reach, Station L-I, Profile 1			
Direction:			
Survey Date: 3/8/2015			
Comments: Riffle stream type

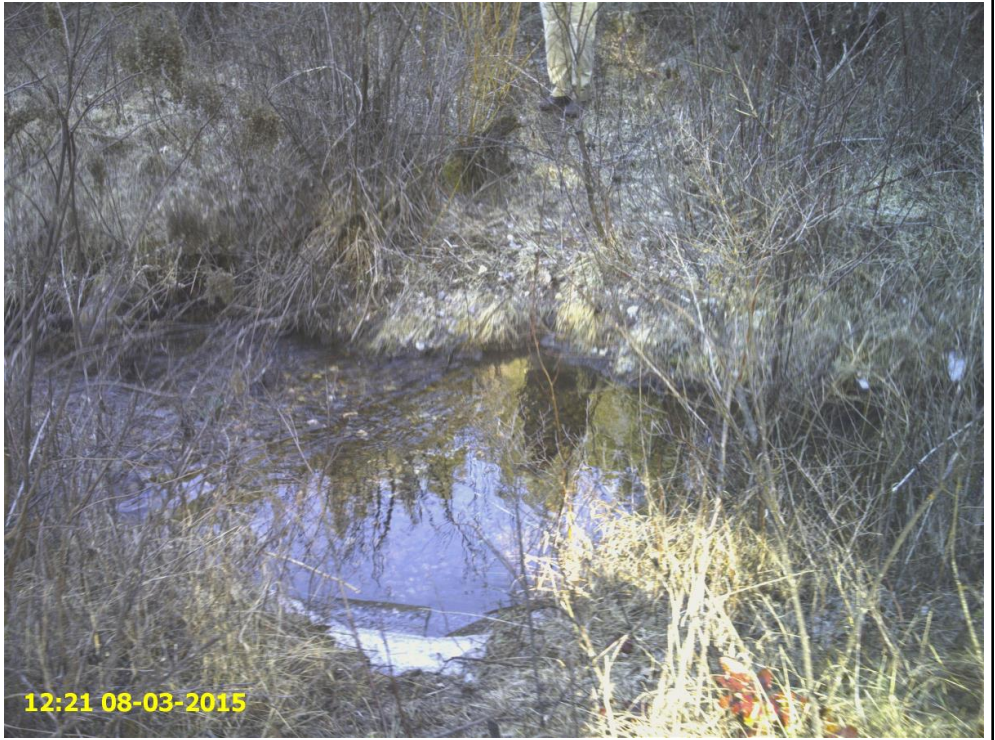
Client:	Newmont	Project:	Lower Blue Creek Reconnaissance
Site Name:	Midnite Mine	Site Location:	Lower Blue Creek
Photograph ID: 39

Photo Location: Lower Reach, Station L-J, Profile 1			
Direction:			
Survey Date: 3/8/2015			
Comments: Riffle/Pool stream type, the person shown is standing on the primary fluvial bench deposits.			
Photograph ID: 40

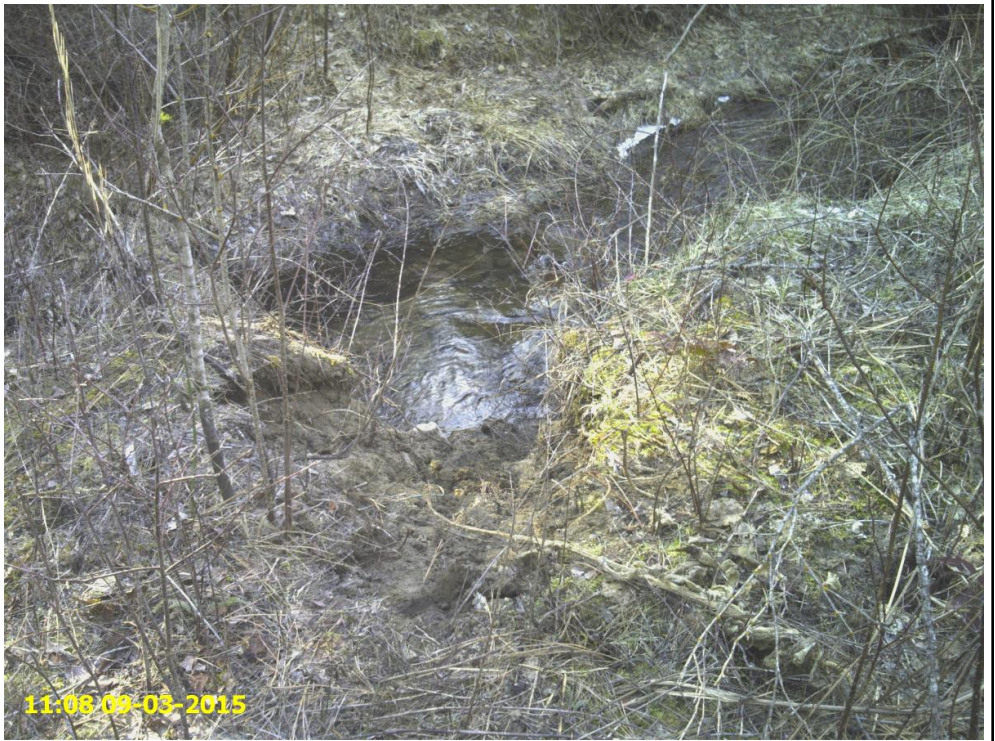
Photo Location: Lower Reach, Station L-K, Profile			
Direction:			
Survey Date: 3/9/2015			
Comments: Channel is deeply incised into the fluvial bench deposits.

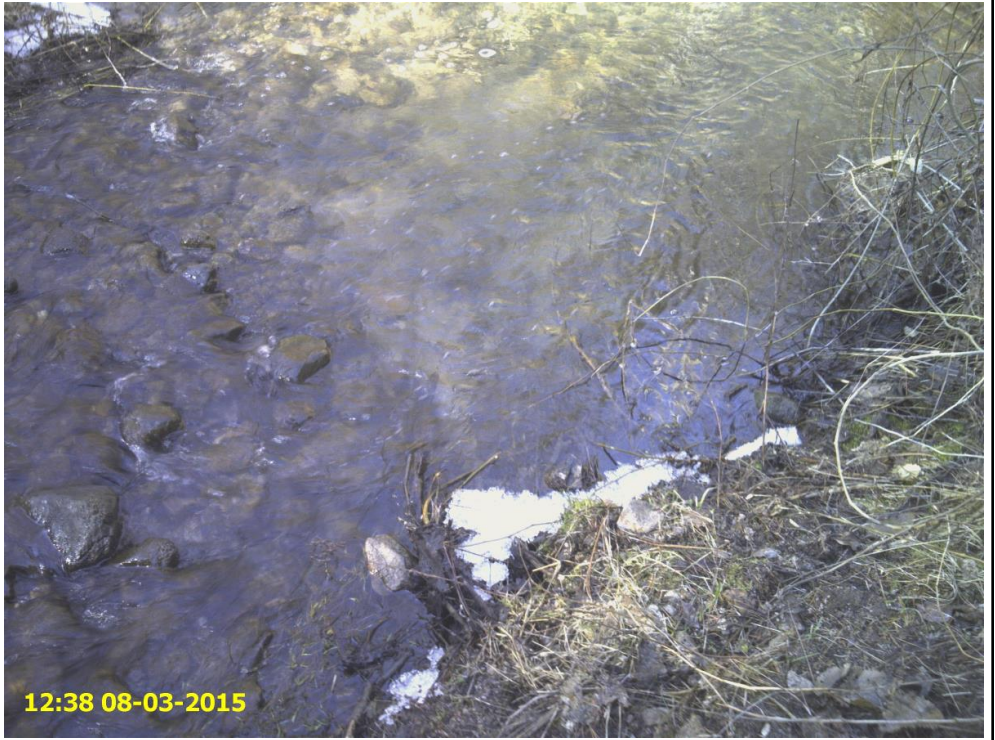
Client:	Newmont	Project:	Lower Blue Creek Reconnaissance
Site Name:	Midnite Mine	Site Location:	Lower Blue Creek
Photograph ID: 41

Photo Location: Lower Reach, Station L-L			
Direction:			
Survey Date: 3/8/2015			
Comments: Riffle stream type. Typical very small deposits of sand and silt-sized material are visible among the gravel and cobbles.			
Photograph ID: 42

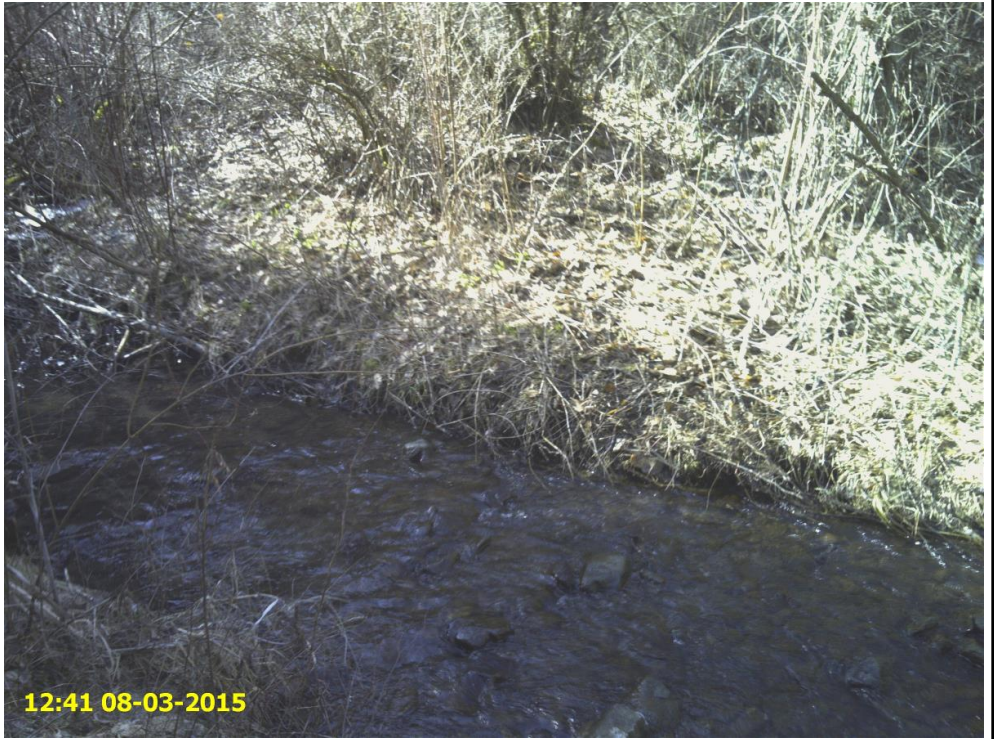
Photo Location: Lower Reach, Station L-L, Profile 1			
Direction:			
Survey Date: 3/8/2015			
Comments: Riffle stream type

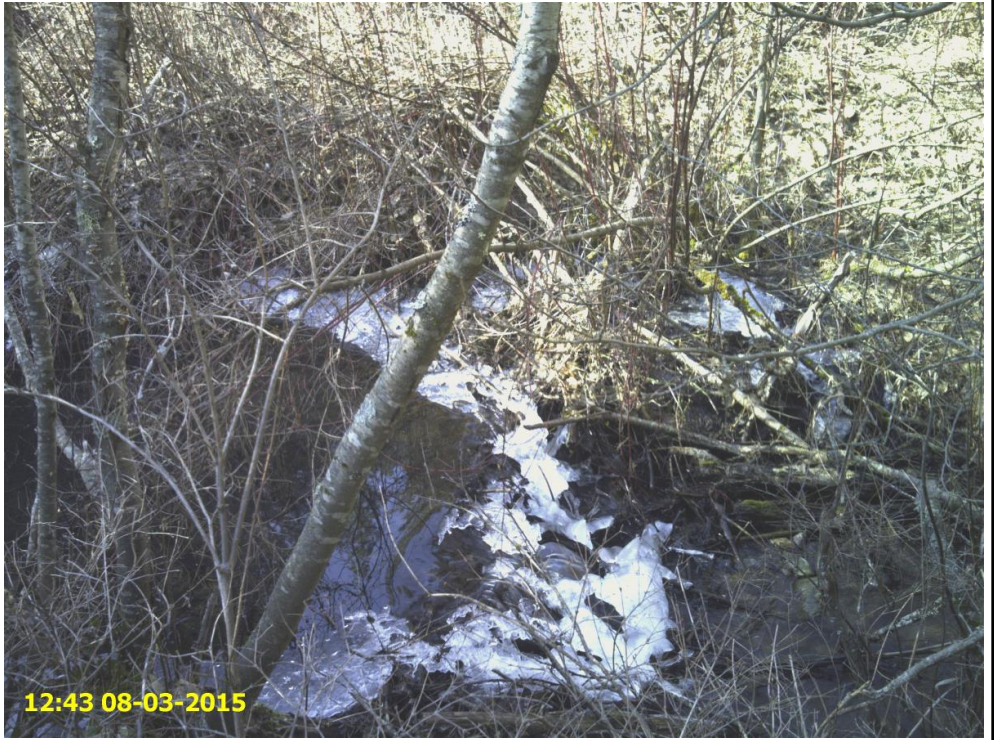
Client:	Newmont	Project:	Lower Blue Creek Reconnaissance
Site Name:	Midnite Mine	Site Location:	Lower Blue Creek
Photograph ID: 43

Photo Location: Lower Reach, Station L-L, Beaver Dam			
Direction:			
Survey Date: 3/8/2015			
Comments: Very small beaver dam is shown.			
Photograph ID: 44

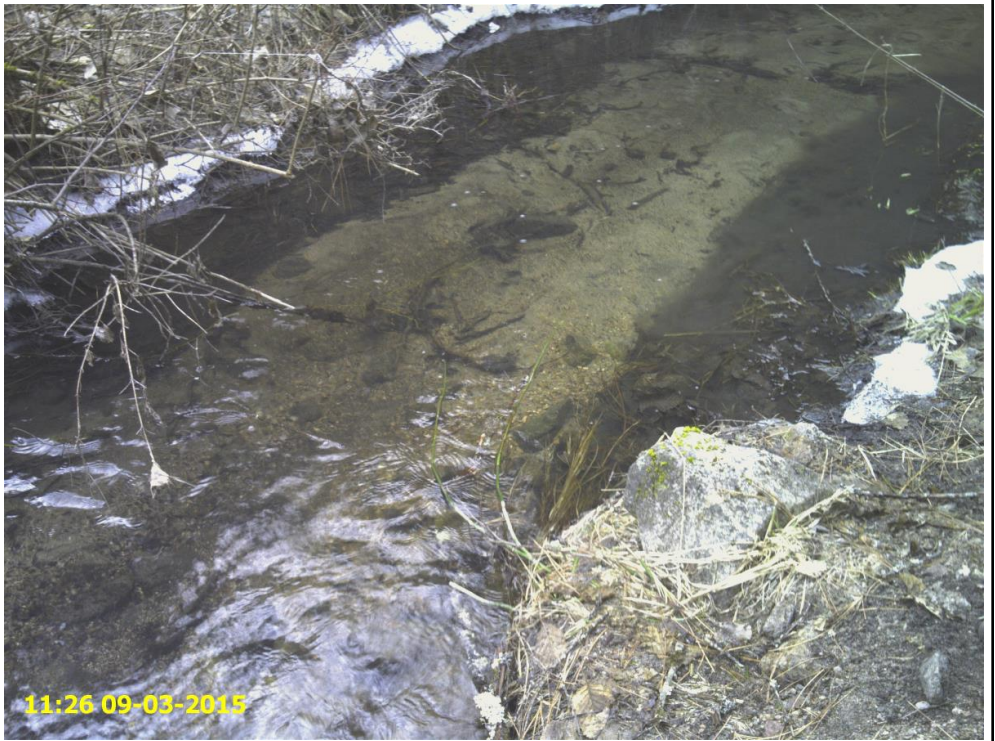
Photo Location: Lower Reach, Station L-M, Profile			
Direction:			
Survey Date: 3/9/2015			
Comments: Run stream type. Sand sized particle sediment is present in the stream bottom.

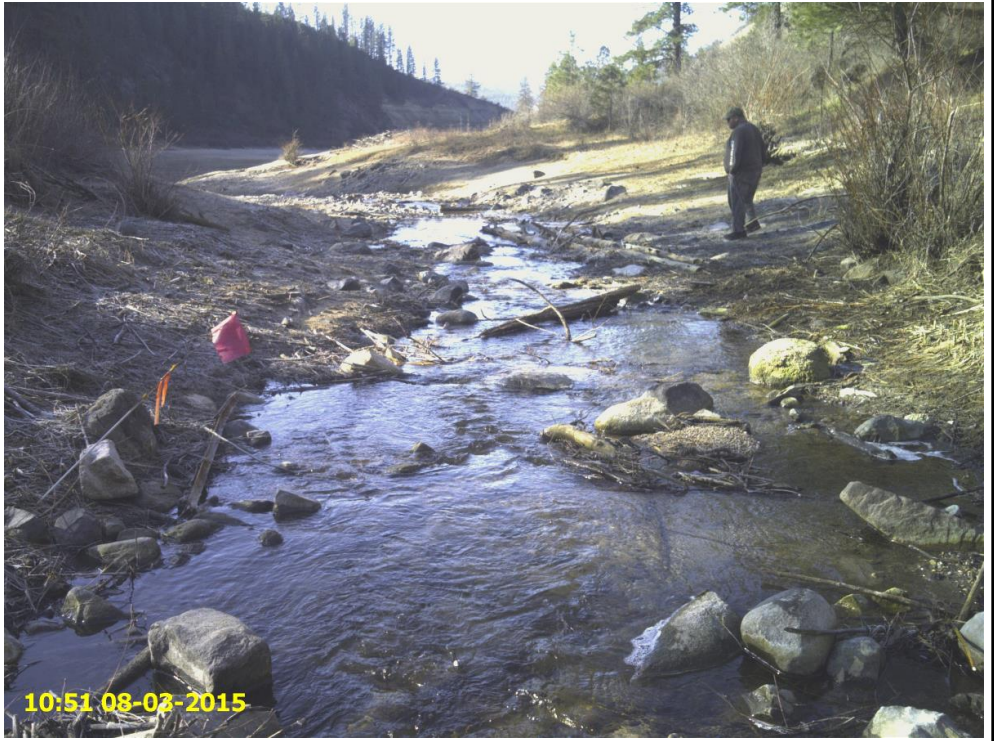
Client:	Newmont	Project:	Lower Blue Creek Reconnaissance
Site Name:	Midnite Mine	Site Location:	Lower Blue Creek
Photograph ID: 47

Photo Location: Lower Blue Creek at the mouth near Lake Roosevelt.			
Direction:			
Survey Date: 3/8/2015			
Comments: The creek at this location is a riffle stream type with large boulders.

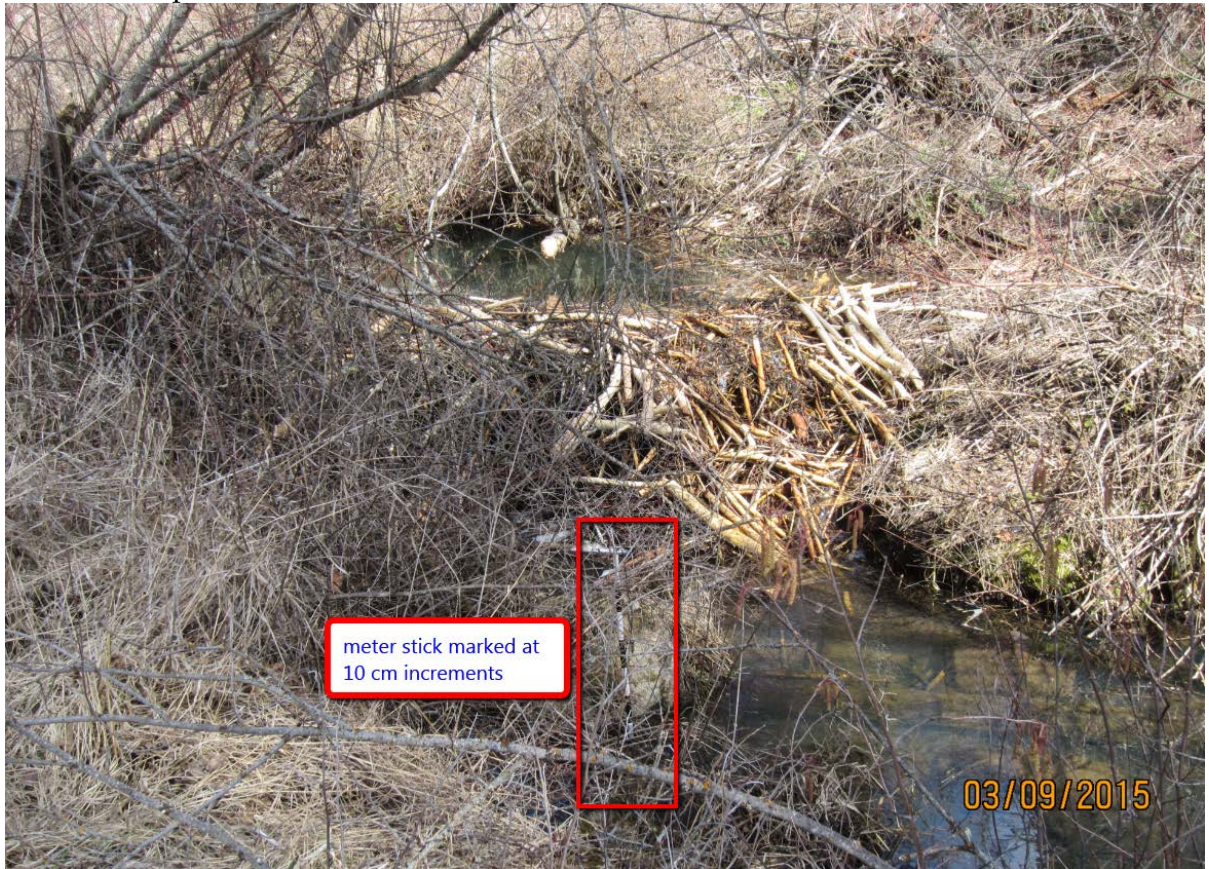
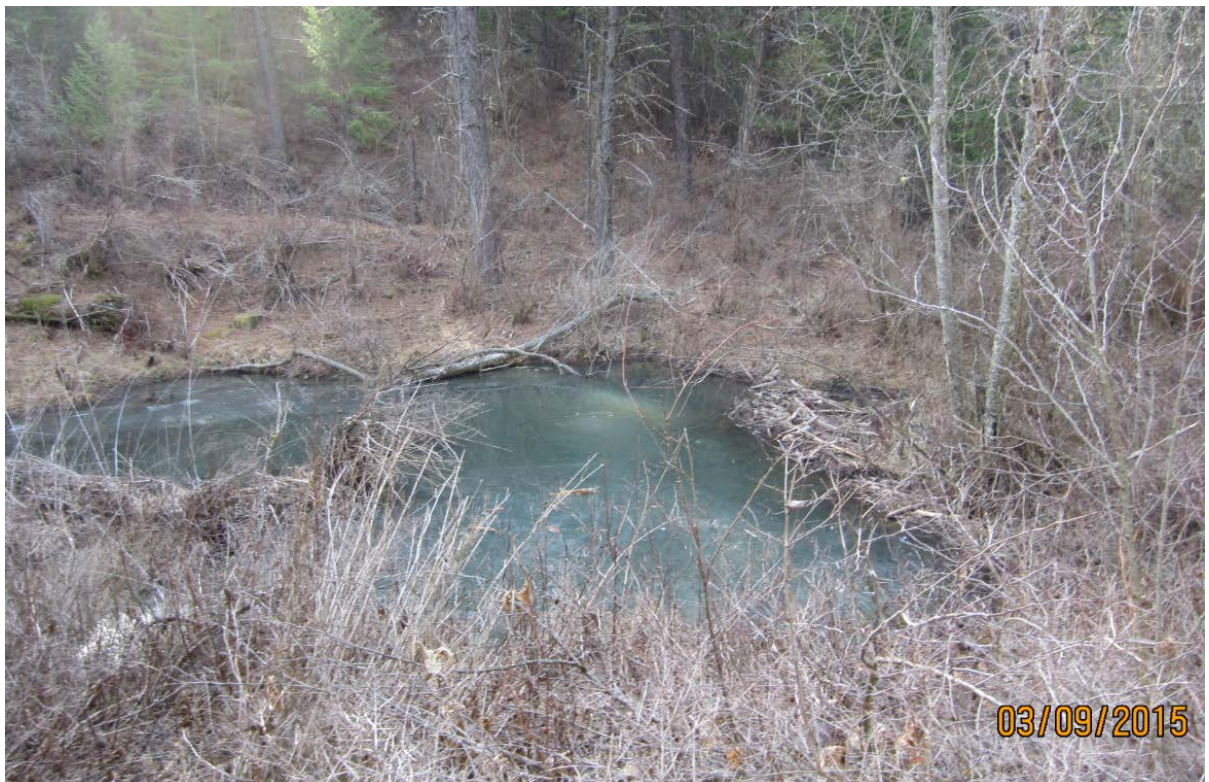
Beaver Dam photos:

- One piece of evidence for the bench being related to relict beaver dam deposits rather than flood benches, is that gravel was observed in them in at least one location. More observations like this would help confirm or contradict this hypothesis.
